Flood Report

Blackmile Lane, Grendon, Northamptonshire

October 2024

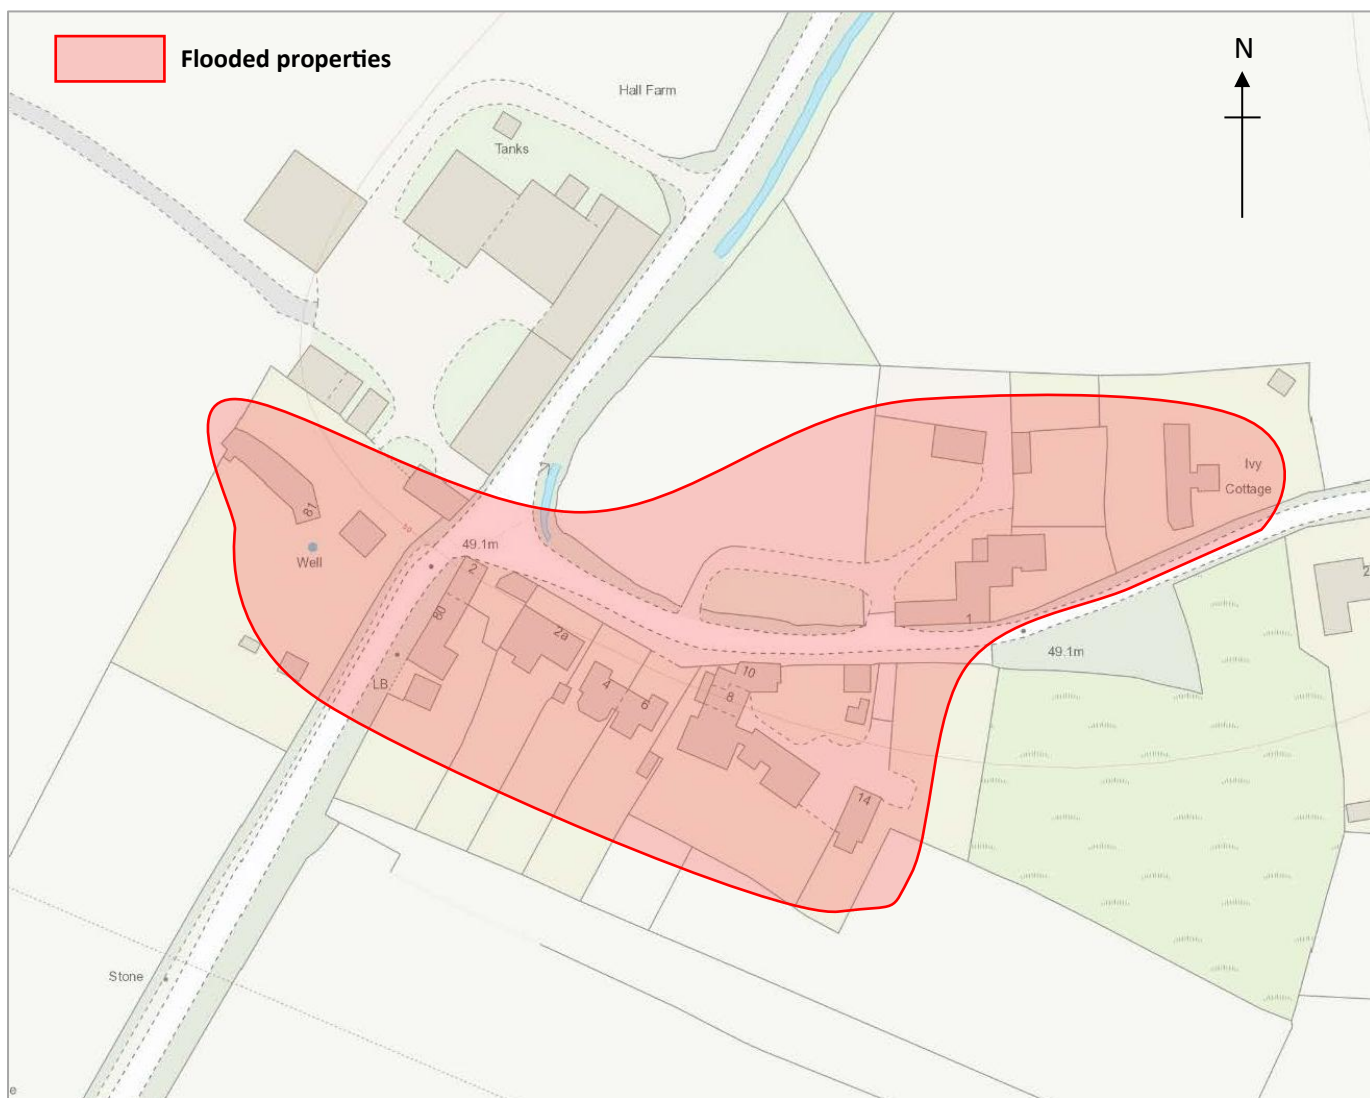
Figure 3: Map showing extent of internally flooded properties © C. Dow

Figure 3 (Location of internally flooded properties) shows the extent of properties within Lower End (Blackmile Lane and Main Road) which suffered internal property flooding. 11 homes reported flood water reaching varying heights on their ground floors.

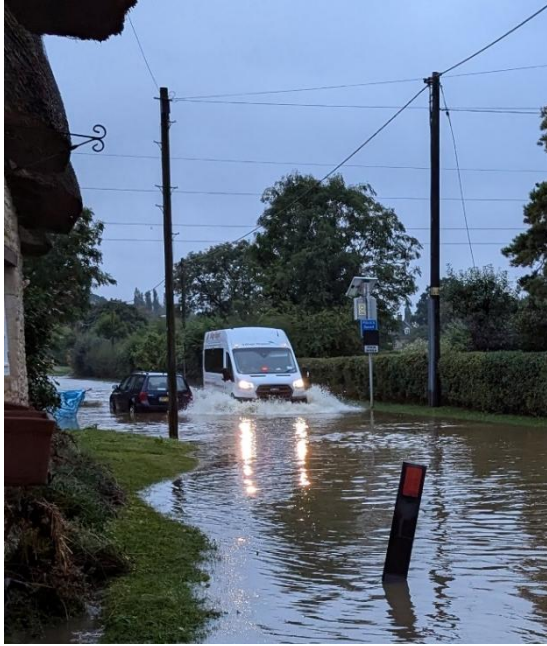
A major issue for the residents of flooded properties was the bow wave of passing vehicles causing contaminated floodwater to flow back into their properties even as they were attempting to remove it. This was caused by Main Road not being officially closed to vehicular traffic until Tuesday 24 September, 48 hours after the flooding started. The official road closure was short lived and vehicles were soon transiting

Figure 4: Vehicles able to risk Main Road as no road closure by the authorities. NOTE bow wave from vehicle washing into stranded car and homes. © C. Dow

- Cooperate with landowners, the Environment Agency and residents to ensure any proposals for flood defences are assessed as promptly as possible
- Develop a more effective way of working with Northamptonshire Police to ensure Main Road is closed to traffic as soon as flooding occurs to prevent danger to lives, loss of vehicles in floodwater and repeat flooding of damaged properties by bow waves of passing vehicles

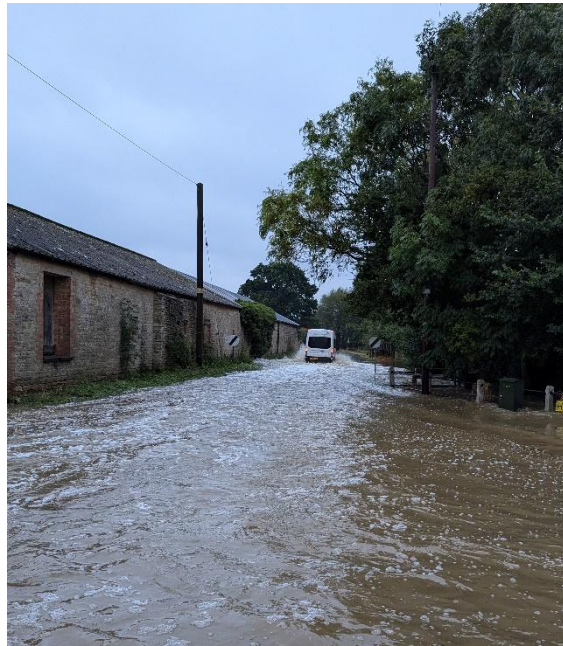
Figure 5: Vehicles able to risk Main Road as no road closure by the authorities. NOTE bow wave from vehicle washing into stranded car and homes. © C. Dow

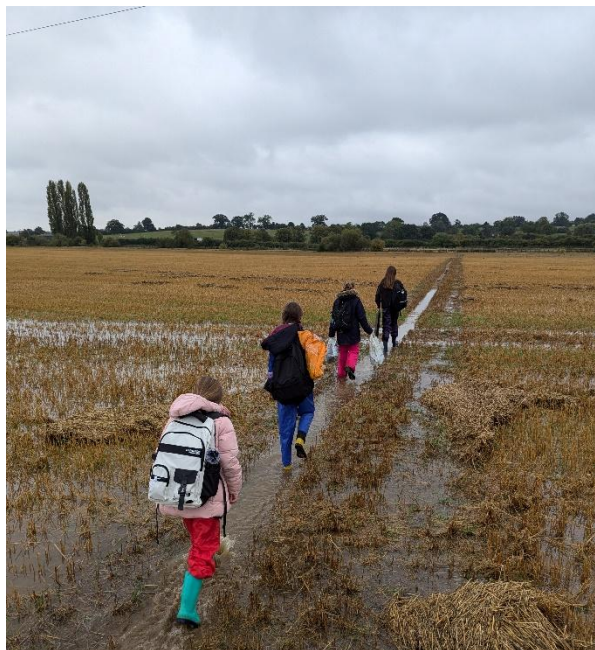
Those residents of Blackmile Lane with properties unaffected by floodwater were effectively stranded for 3 days (Monday, Tuesday and Friday) as the only vehicular exit from the lane was underwater. On a wider scale, Grendon Primary School had to close for three days (Monday, Tuesday and Friday) and traffic had to be diverted due to the closure of Main Road.

Figure 5: School children crossing fields to bypass a flooded Main Road for onward transit to schools in Denton and Kettering where they were driven a long way around to avoid the flooding as, no alternative access exists © C. Dow

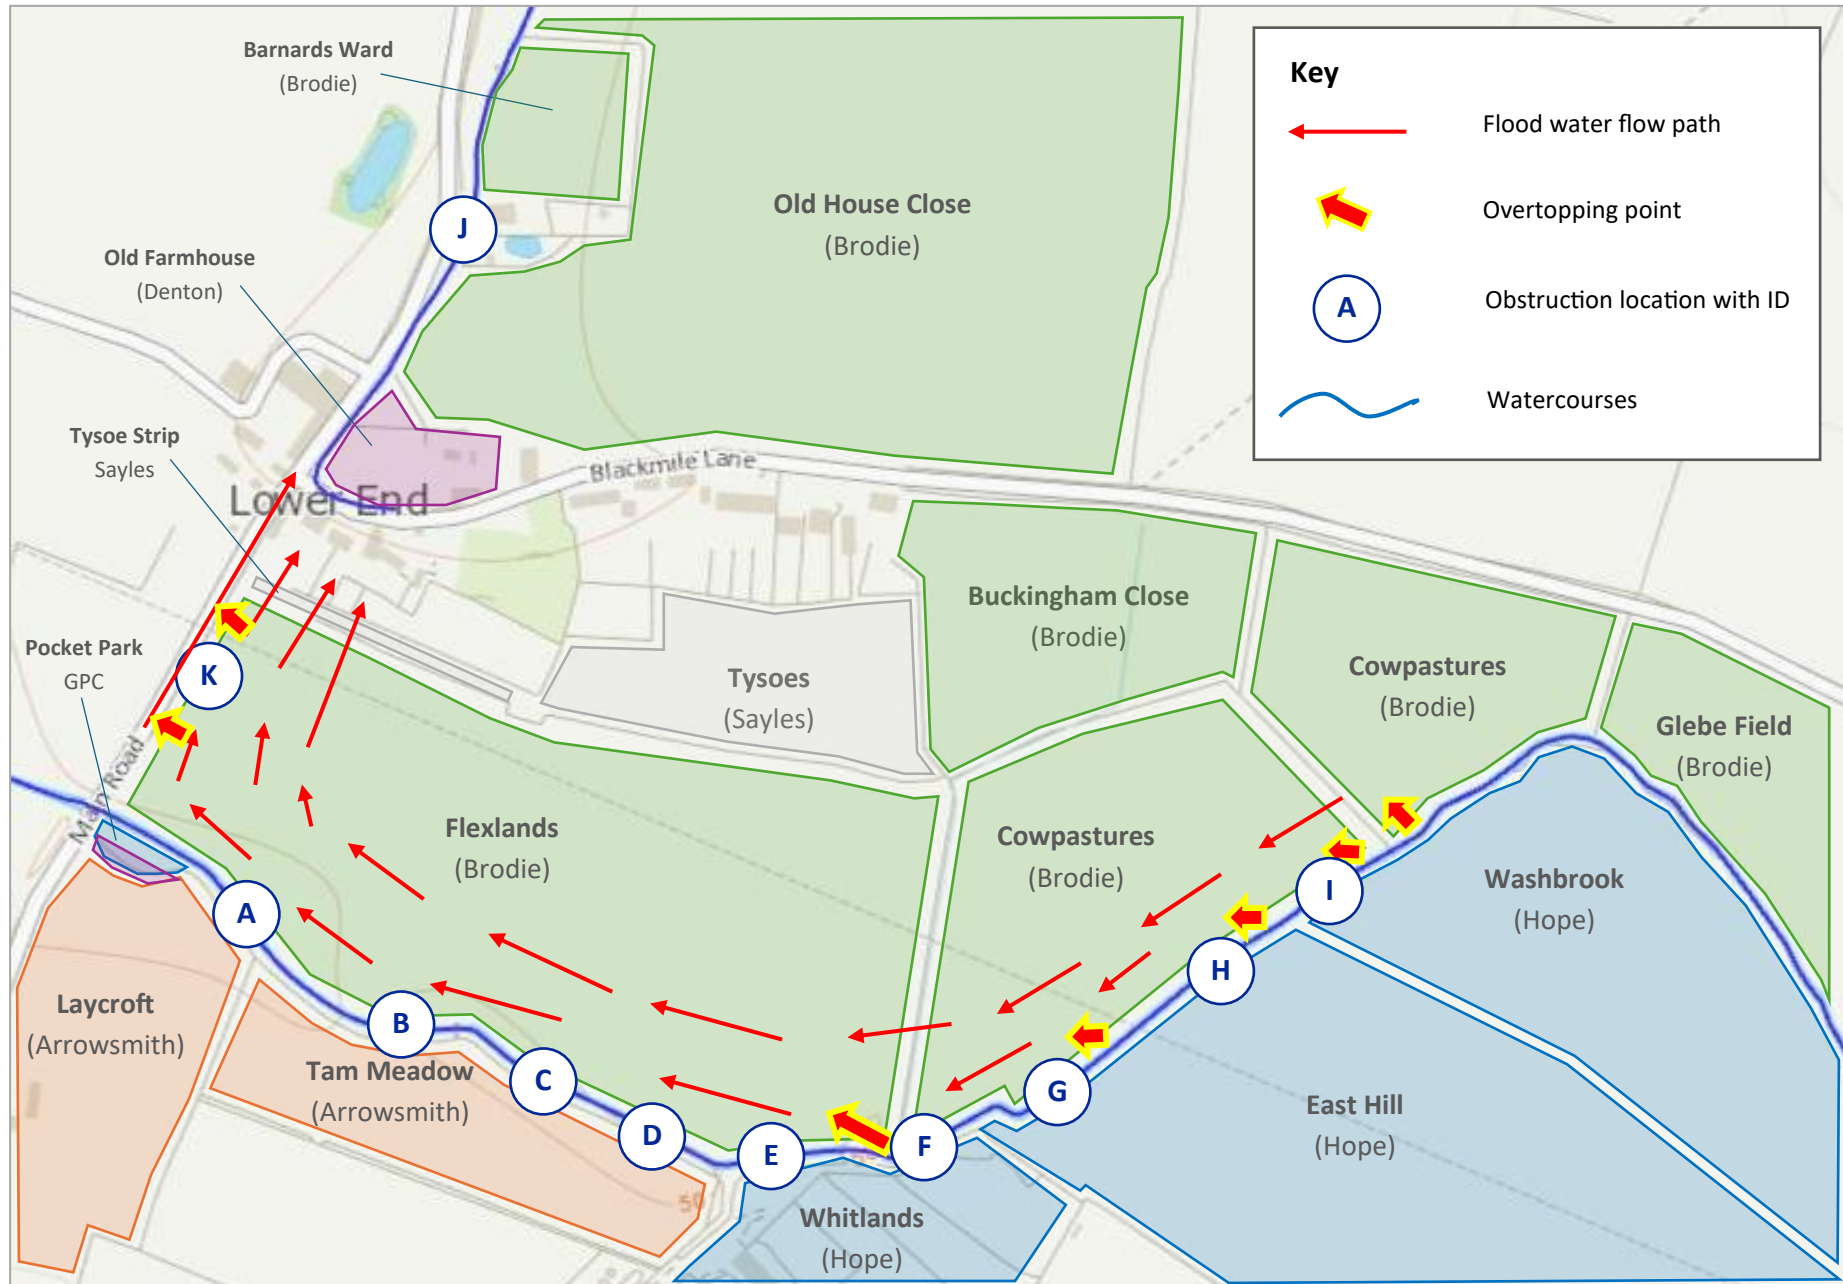
Figure 6: Map showing location of obstructions, overtopping points and flow path of floodwater. Map produced with the kind assistance of P. Goffey. © C. Dow

Evidence along Grendon Brook between Main Road and the field known as Cowpastures (see figure 5) shows that the Brook backed up due to multiple obstructions in the channel and on both the north and south banks.

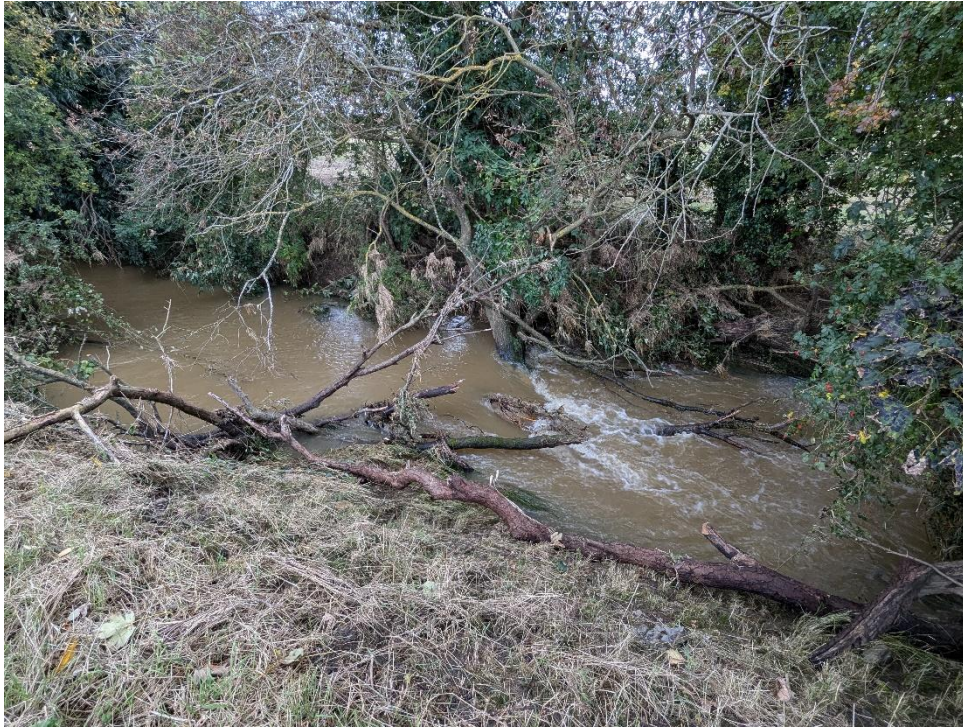
Figure 7: Vegetation and detritus on banks and in channel (Obstruction F) obstructing water conveyance in Grendon Brook. © C. Dow

- 2) Multiple obstructions along the banks and bed of Grendon Brook restricted the water conveyance and most likely caused it to be held up and pool at a point adjacent to the field boundaries of Cowpastures East and West;

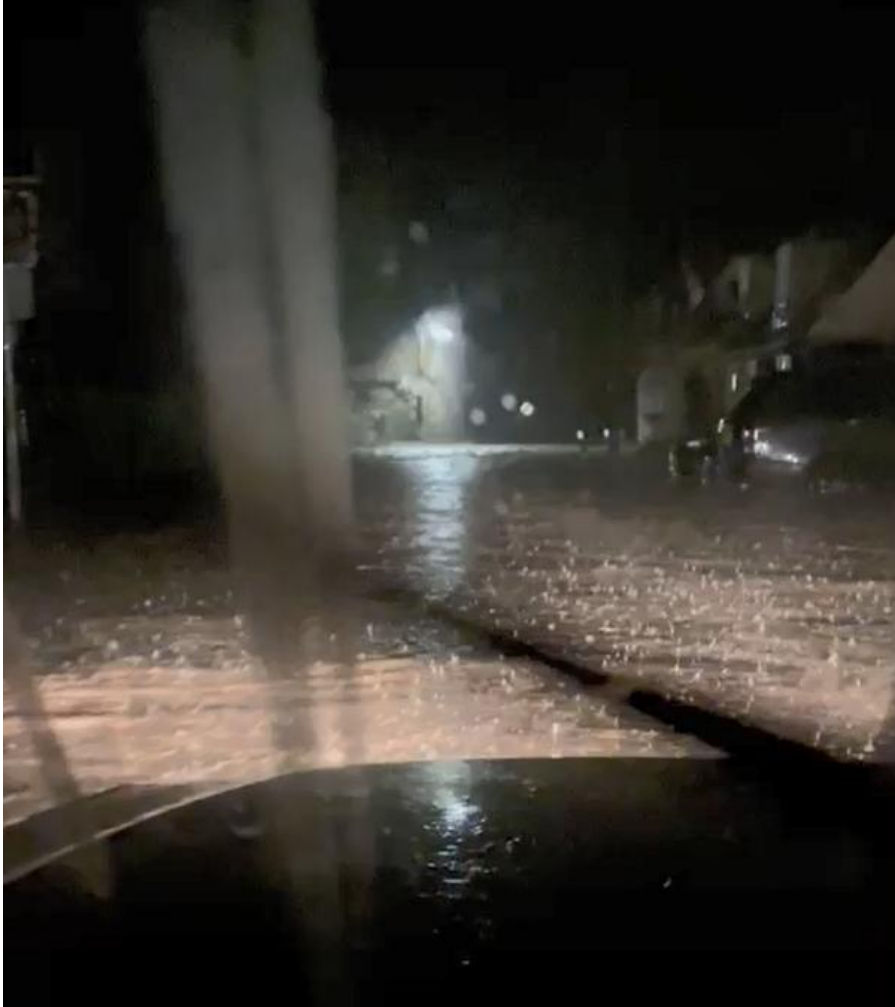
Figure 8: Video still taken from a Land Rover Discovery by 80 Main Road heading North at 20:50 on 22 Sept 2024, NOTE: the floodwater is level with the bonnet (circa 40inches deep) © E. Bilson.

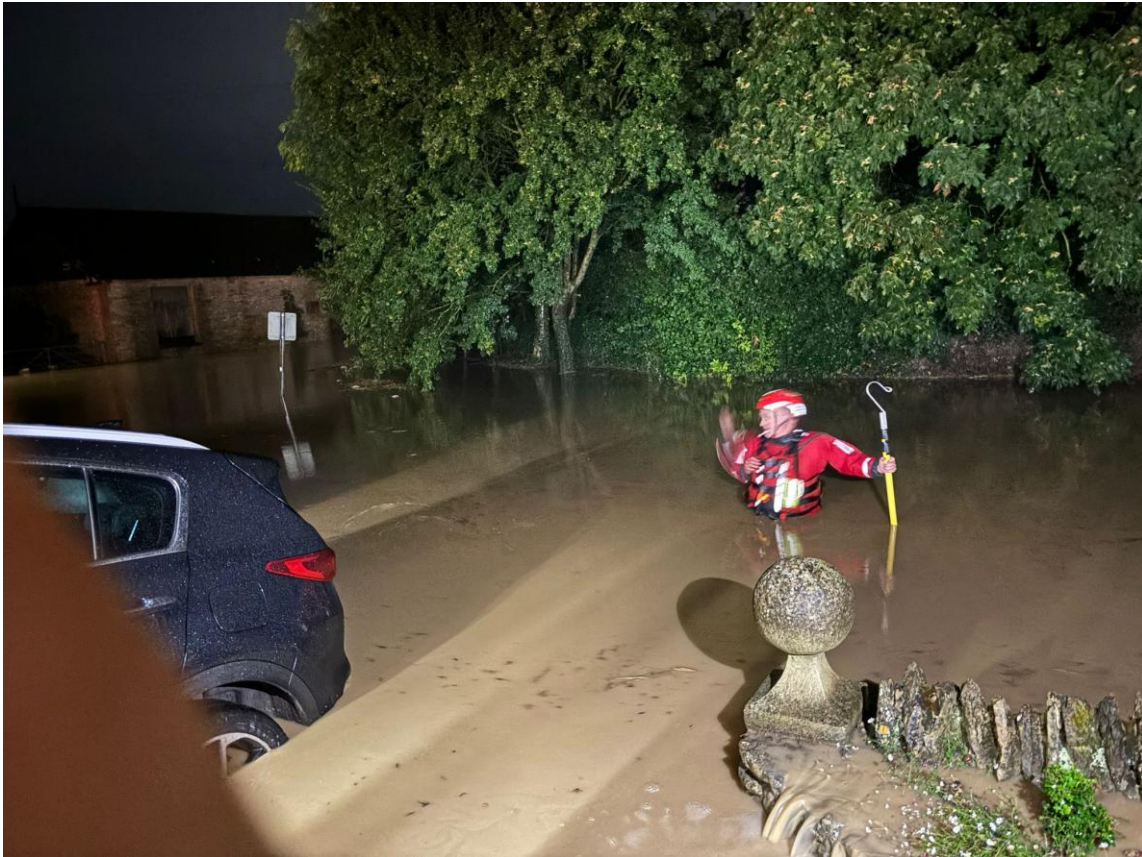
Floodwater collected at this location from the three sources (Main Road, the rear of properties, and Gibbards Arm). It then rose to a depth of at least 1.3m in Blackmile Lane where it entered properties and caused internal damage. Floodwater levels remained high for 48 hours.

Figure 9: Picture taken from 2a Blackmile Lane at 22:52 on Sunday 22 September 2024 showing depth of floodwater on the lane on rising ground © P. Knuff

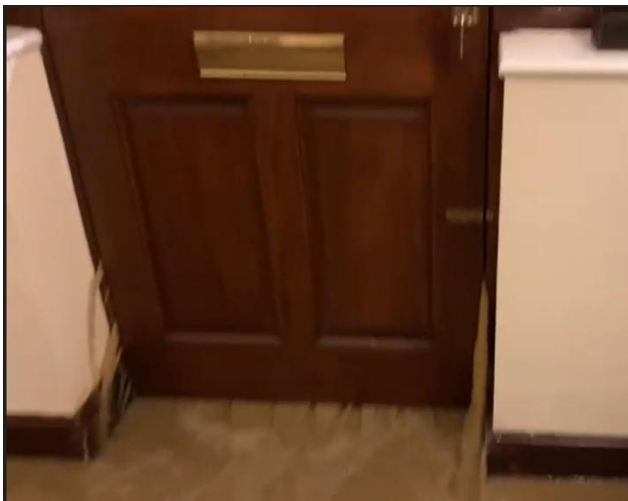
Figure 11: Video still of floodwater entering No. 8 Blackmile Lane on Sunday 22 Sept 2024. (c) R. Blacklee

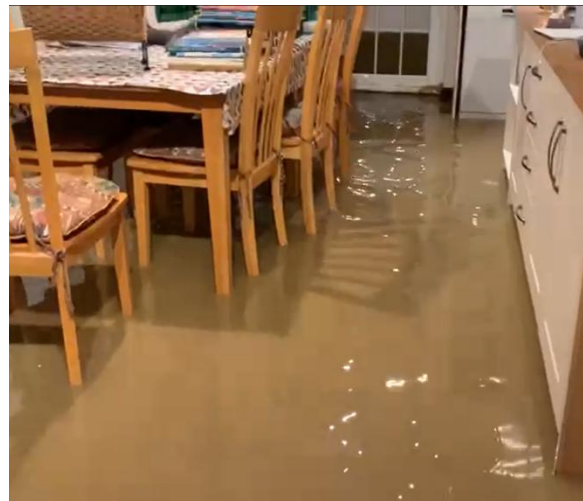
Figure 10: Video still of Internal flooding to No. 8 Blackmile Lane on Sunday 22 Sept 2024. NOTE water entering via door in background. (c) R. Blacklee

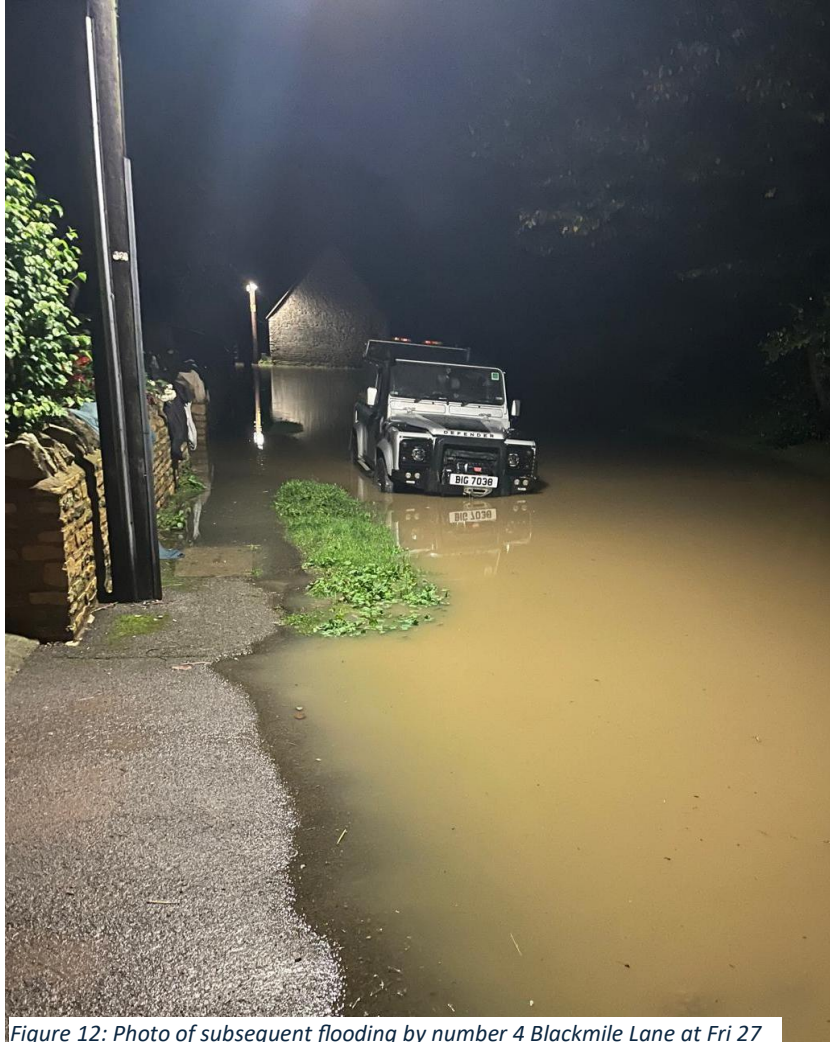
Heavy rainfall occurred again overnight of Thursday 26 / Friday 27 September 2024. This caused significant flooding to Lower End although not sufficient for it entering properties. It is felt that this followed the original flow routes which combined with the volume of rain led to the existing drainage systems failing.

Figure 12: Photo of subsequent flooding by number 4 Blackmile Lane at Fri 27 Sept at 03:30. © N. Blacklee

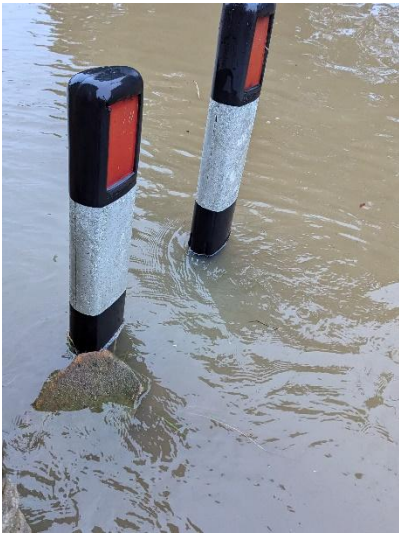
Figure 14: Height and flow speed of floodwater at junction of Blackmile Lane and Main Road on morning of Monday 23 Sept 2024. (c) C. Dow

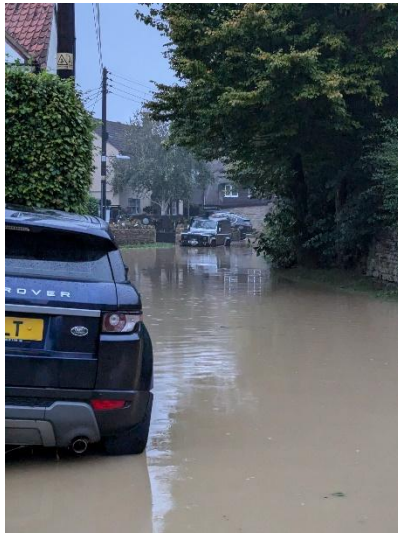
Figure 13: Height of floodwater at No. 10 Blackmile Lane on morning of Monday 23 Sept 2024. (c) C. Dow

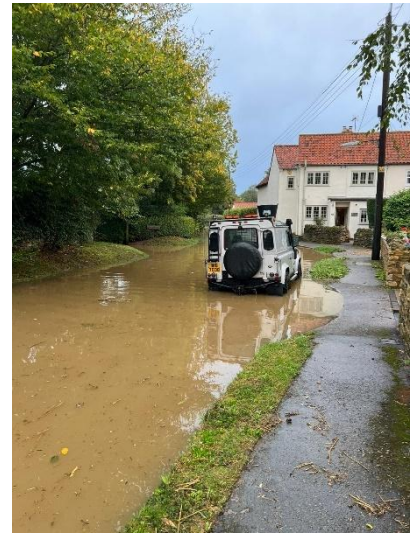
Figure 15: Height of floodwater at No. 2 Blackmile Lane on morning of Tuesday 24 Sept 2024. (c) C. Dow

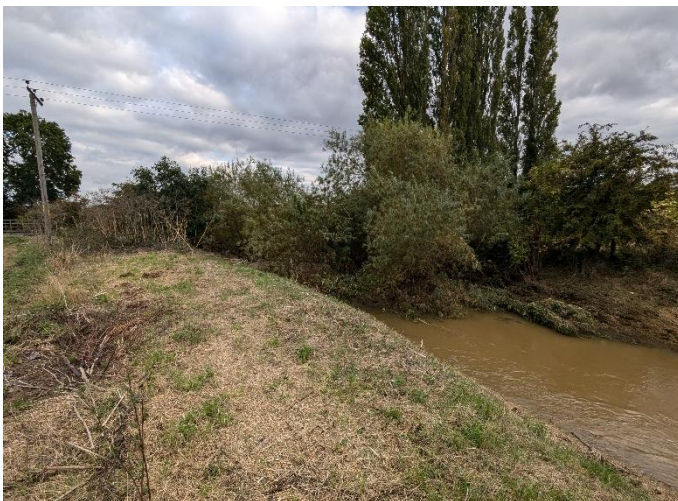
Figure 17: Vegetation on both banks and in channel of Grendon Brook (Obstruction E). (c) C. Dow

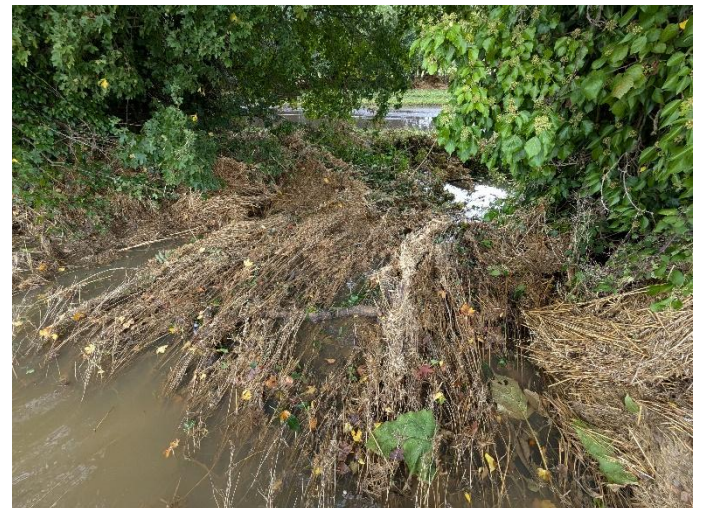
On reaching the boundary of Flexlands and Main Road, the floodwater collected and built temporary dams of detritus (stubble stalks). The floodwater then increased in this area and due to the topography of the field it then spread northwards towards the rear of the properties on Blackmile Lane.

Figure 16: Example of a breached detritus dam from Flexlands onto Main Road at Obstruction K. © C. Dow

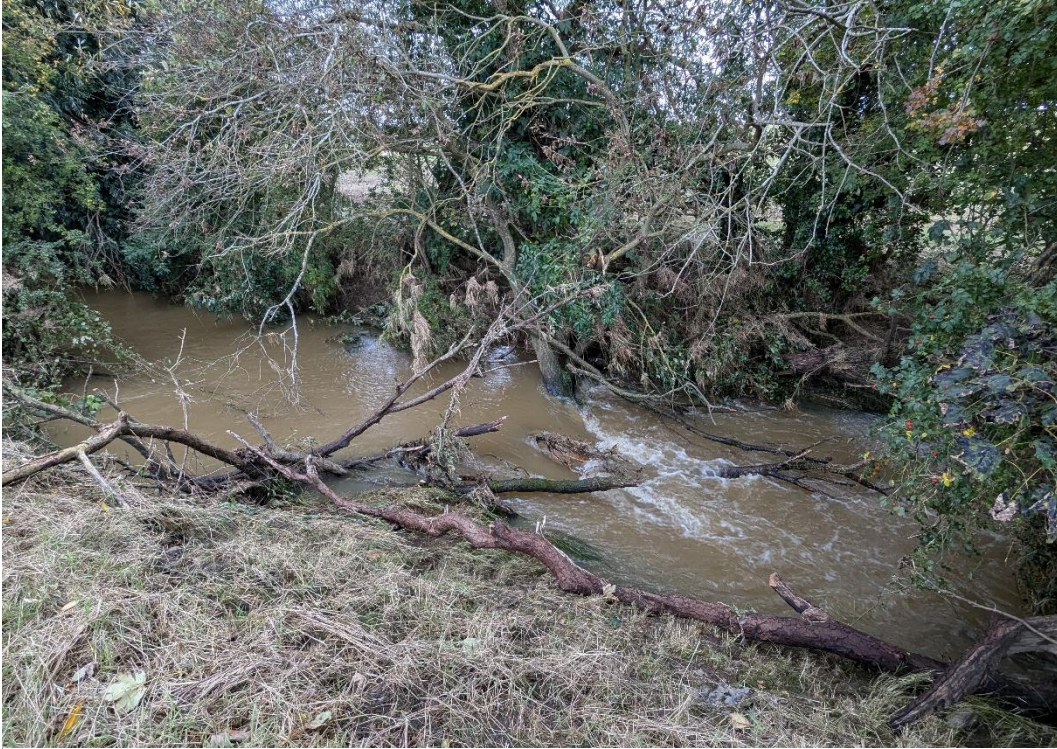
Figure 18: Obstruction H with high water levels in Grendon Brook. © C. Dow

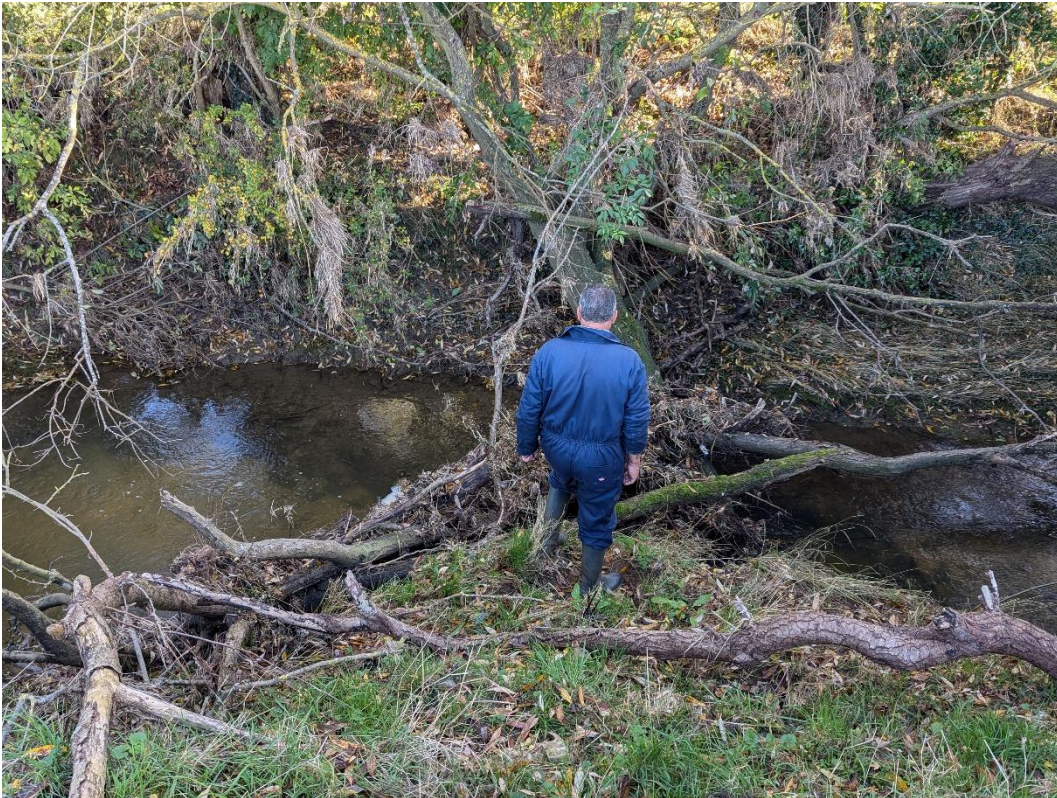
Figure 19: Obstruction H during subsequent low water levels in Grendon Brook with resident for scale showing size and extent of blockage as well as difference in water levels up and down stream of obstruction, illustrating its effect at holding back water. © C. Dow

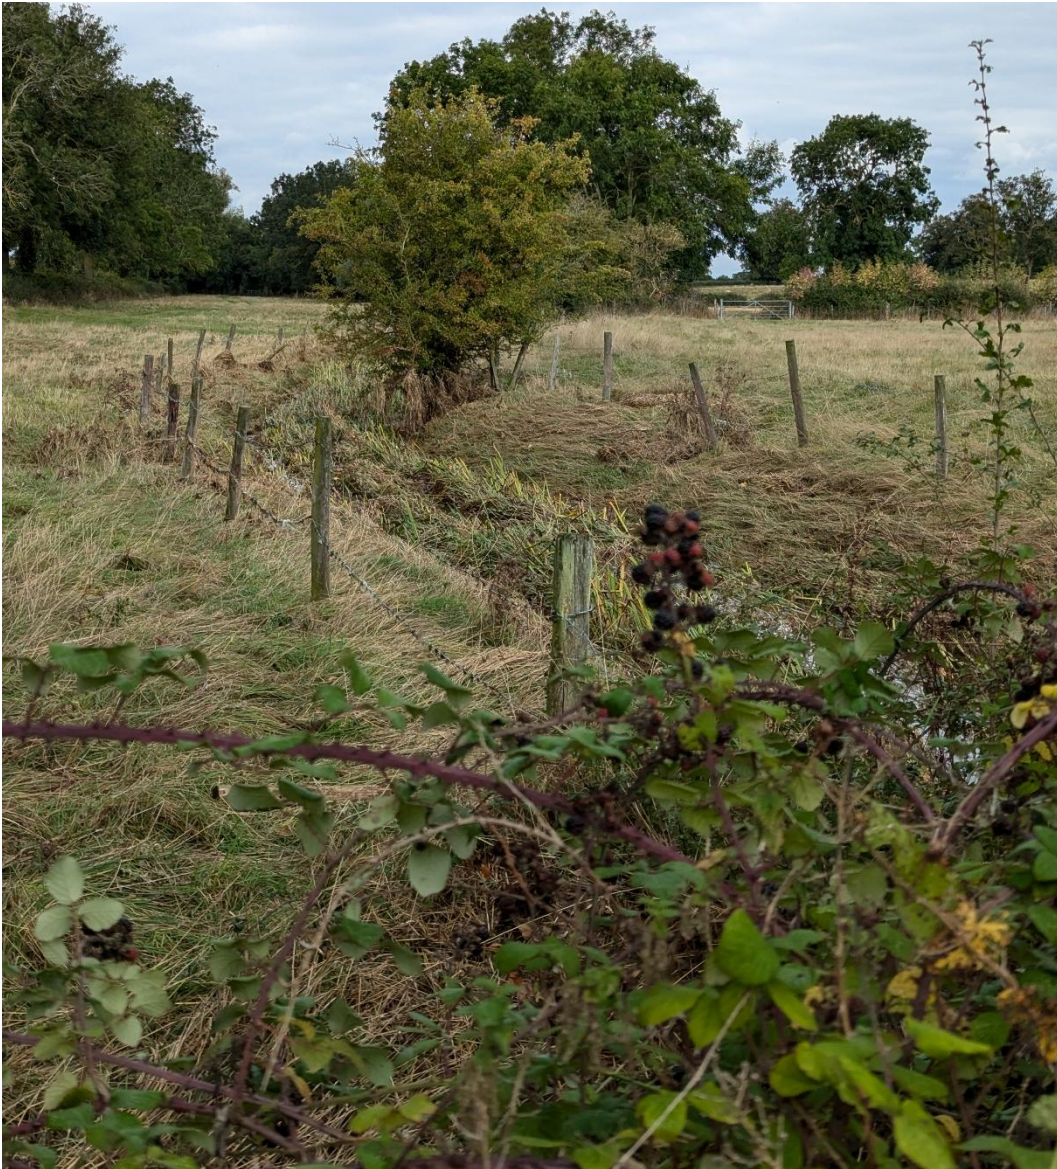
Figure 20: Obstruction J on Gbbards Arm showing overgrown channel banks and bed. © C. Dow

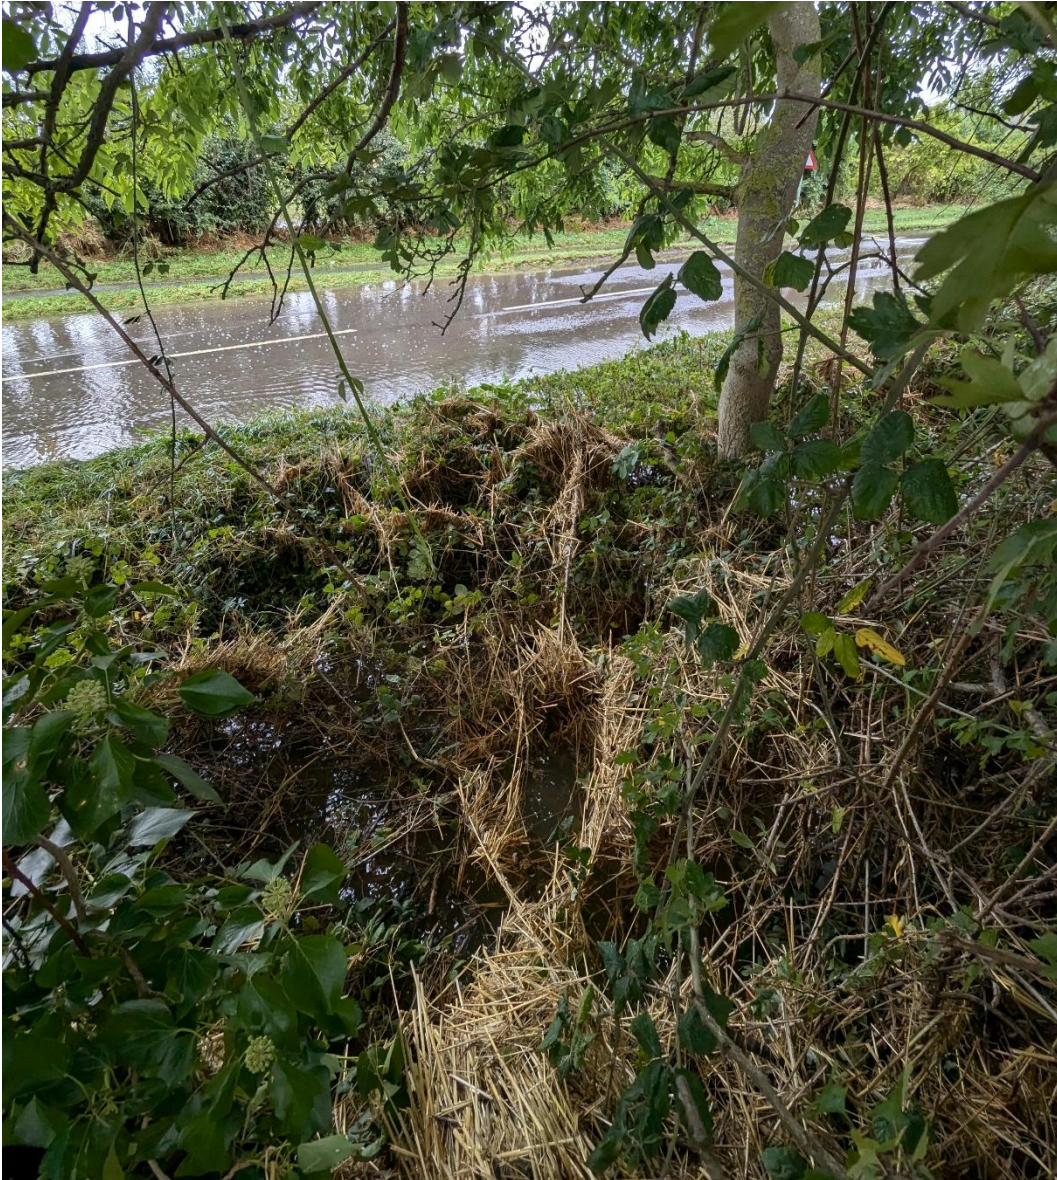
Figure 21: Obstruction K showing overgrown and filled in condition of ditch along Main Road adjacent to Flexlands field running to Grendon Brook. Note mature tree growing in centre of ditch. © C. Dow
