Flood Report

Blackmile Lane, Grendon, Northamptonshire

October 2024

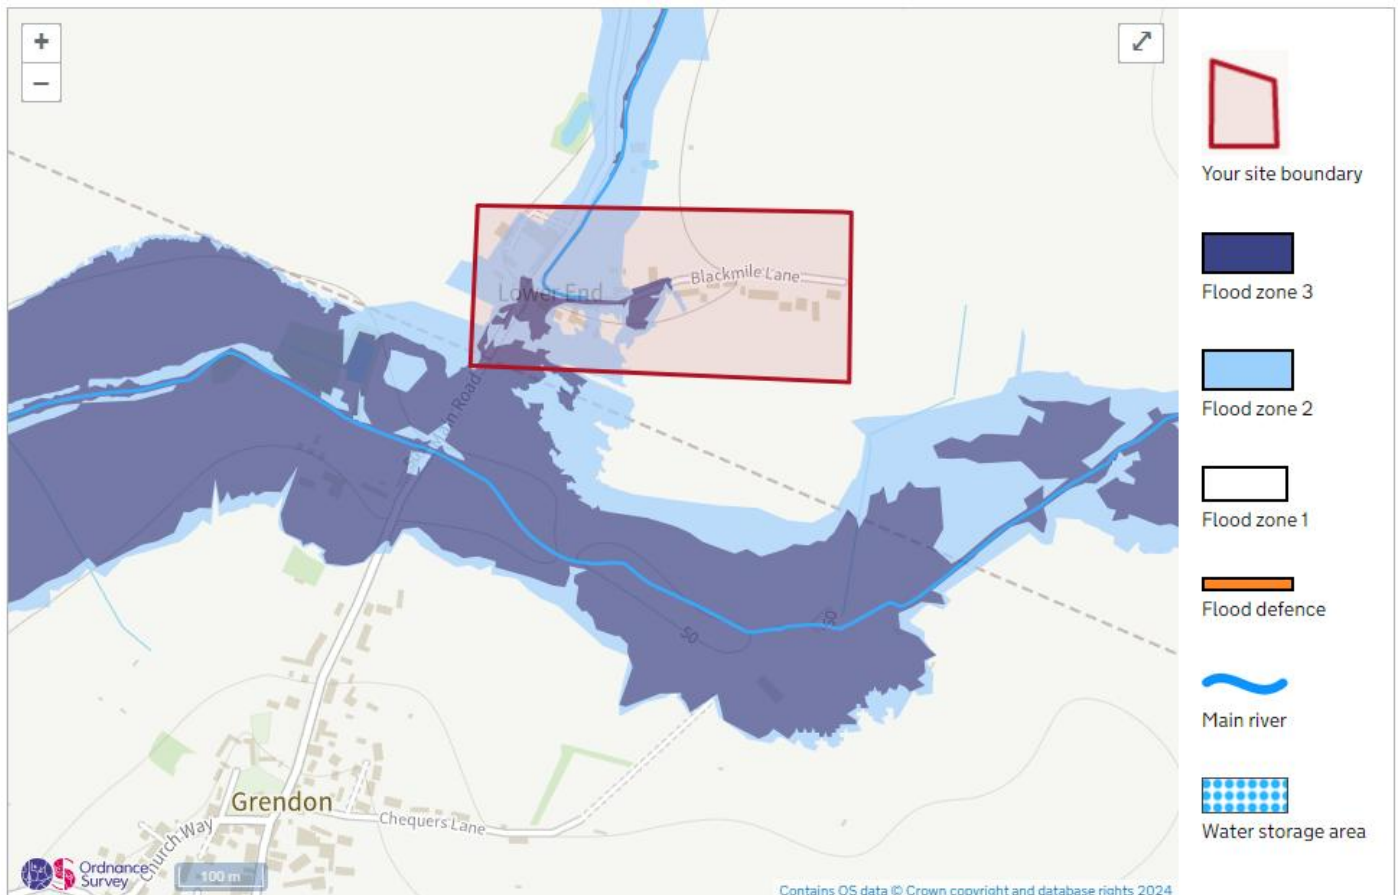
The Flood risk map below highlights the topographical features and the low-lying nature of Lower End. The September 2024 incident is unusual in that properties outside of the flood zones shown above suffered internal flooding which raises questions about the source and direction of travel of the floodwater.

Figure 2: Flood risk map of Lower End including Blackmile Lane (© Environment Agency)

It will be noted that the properties affected by flooding in September 2024 all lie within the area shown as being in flood zone 3. This is described by the Environment Agency and planning authorities as having “a high probability of flooding from rivers and the sea.”.
